Peshtigo School District

Facility Study
August 3, 2020

Re: Preliminary Facility Study and Report

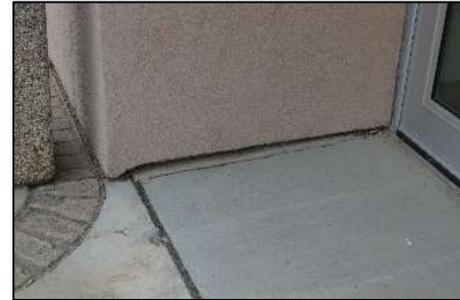
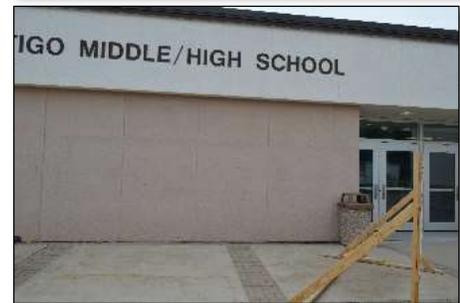
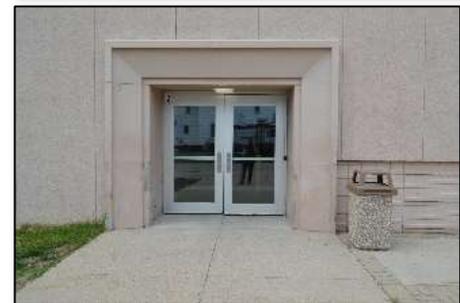
- **Main Entrance A:** Main entry door was renovated in 1983 with synthetic plater over rigid insulation. This is commonly referred to as Exterior Insulation Finish System or EIFS. The technology behind these types of products was poor during its earlier applications and this product should never be installed within 24" of the ground plane. It should also never be installed adjacent to a walking surface in cold weather climates as de-icing salts are typically deployed and will damage the finish. The aluminum storefront was also installed during the 1983 renovation and the perimeter sealant appears to be in distress and may have a mildew growth on its surface. Over time the sealant can fail if not properly installed or is found to be incompatible with the adjacent construction.

- **Exit 2:** Door 2 is also aluminum storefront and exhibits similar issues with the sealant as the main entrance. This entrance is adorned with a cast stone frame and in the 1983 renovation paint was applied to the surface of the stone to match the aesthetic of the rest of the exterior renovations. It is not recommended to apply paint to exterior concrete or masonry facades. Stone, clay and concrete exterior building materials need to naturally breath as to expel water vapor that inherently tends to infiltrate the material. If paint is applied to the surface to prevent moisture from being absorbed into the material, and water vapor cannot escape through the drying process, it will be trapped behind the paint. This will cause cracking, spalling and general failure of the material due to the freezing and thawing of the moisture trapped behind the paint. The paint is now peeling and flaking off the surface due to the moisture's attempt to escape.

- **Exit 3:** This door is the exit to grade from the wrestling room added in 1983. This door appears to have been recently re-painted and is in good condition.

- To improve thermal transfer rates, it is recommended that the older aluminum framed systems are replaced with new thermally broken aluminum storefront systems with Low E tempered insulated glazing. Hollow metal doors should be inspected for surface rust and repainted if necessary. Inspect and replace weather stripping systems. Overhead door should be repainted and inspect the weather-stripping.

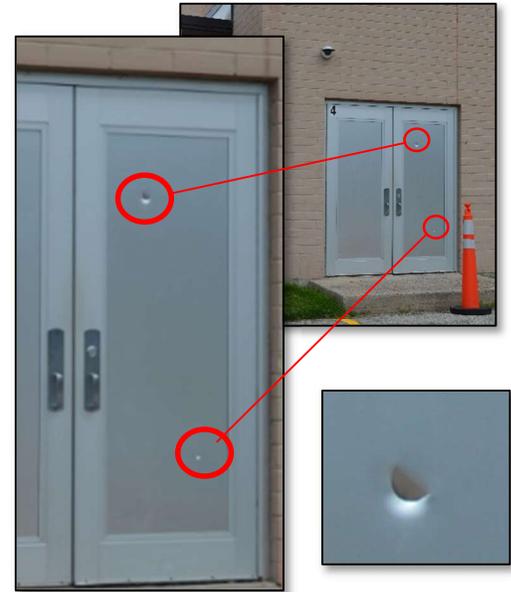
- Exit 4:** This door is an aluminum framed double emergency exit door with spandrel panels in the leaf lite openings. These are likely insulated panels and it is unclear if these were originally full light glazing as the 1983 addition drawings specify these doors as flush slab. There are two points of damage in the spandrel panels. The lower dent has not broken through the surface; however, the upper dent has. The damage that has compromised the surface will cause deterioration in the insulation in the core. The reduction in thermal value will eventually cause condensation on the interior surface behind the hole.

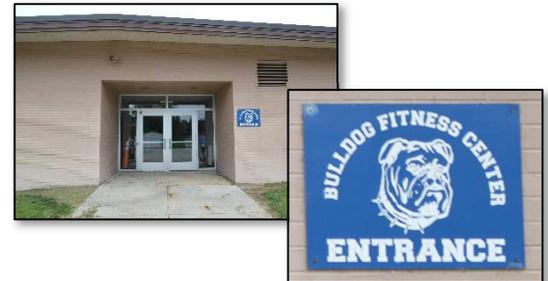
- Entry/Exit 5:** Door No. 5 serves as an exit as well as the public entrance to the fitness center. A full lite aluminum entry that also appears to have potential mildew growth on the perimeter sealant. Being a public entrance for a community amenity, this entrance has a security issue associated with it. The general public that use the fitness center have access to the entire school once they traverse the vestibule. Storefront framing usually requires a weep path at the base of the assembly to prevent condensation build up within the frame. The sealant at bottom of the sidelights on each side of the doors prevents them from properly weeping if the aluminum entry system requires it.

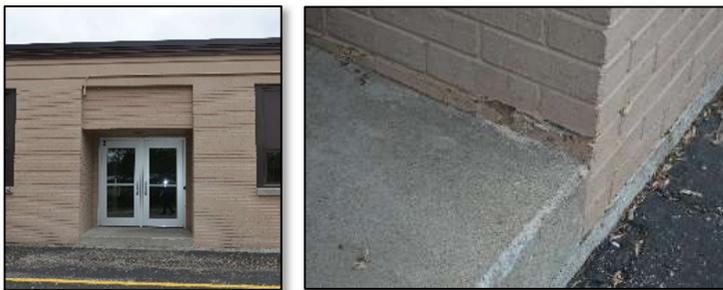
- Exit 6:** This door is in relatively good condition, however there is trim at the perimeter that has been fastened to the face of the frame compromising the integrity of the frame. The trim has been interrupted to accommodate a keyless entry receiver.

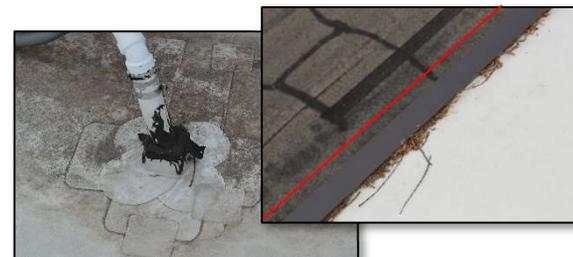
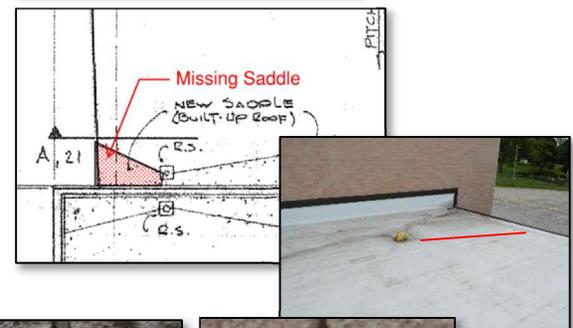
- Roofing:** The roof is a white TPO membrane on tapered insulation. The roof is fairly new and for the most part cleanly installed. There are a few spots with excessive amount of patching deployed which is a concern as to why that was necessary. The roof edge should have a cap sheet or the roofing membrane covering its edge to prevent the collection of debris. This could also take on water if the volume of rainfall allows the roof to retain water up to the roof edge. This could cause damage to the fascia substrate. A larger issue of concern is at the overhang adjacent to the Multipurpose room as mentioned in the overhangs section. There is a missing tapered insulation saddle under the roofing membrane. The saddle is required to divert water away from the roof edge and to the roof drain. Because this saddle is missing it is causing significant damage to the overhang, fascia and adjacent masonry wall.

- **Control Joints:** All failing control joints should be removed, and new systems installed.
- **Roofing:** First priority action is to repair the issue with the missing saddle to stop the storm water from spilling over the overhang adjacent to the multi-purpose room. Annual roofing inspections are recommended to stay ahead of any issues that may arise. Thermal imaging roof scans are recommended bi-annually or at least every three years as this process can detect leaks that have not found their way to the roof structure and into the building.

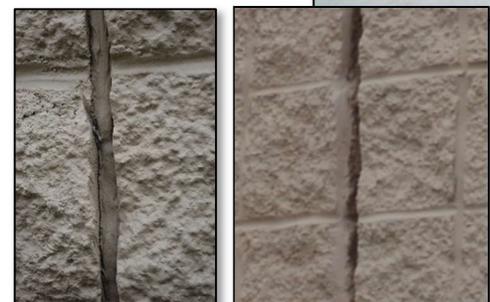
- Control Joints:** A sample of masonry control joints were observed to be failing. The sealant is separating from one side or the other of the masonry joint. This is due to the movement of the building and possibly incompatibility with the masonry material. Failures such as these will allow water to infiltrate the wall cavity.

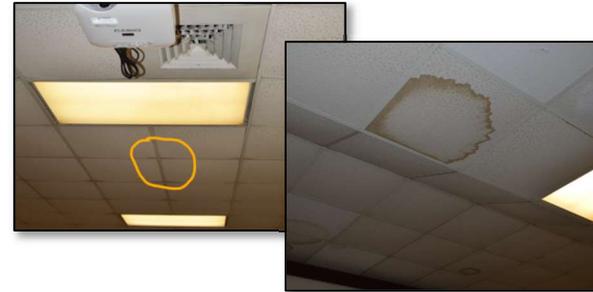
- **Ceilings General:** Acoustical Ceiling tile are in relatively good condition with only a few locations with mismatched, missing or damaged tiles. 2X2 ceiling grids exist in most spaces preventing the extreme sagging that occurs with 2x4 systems and summer humid conditions. However, without the presence of cooling throughout the building, even the square cut 2x2 tiles will sag at the center and curl at the corners.

- Ceilings:** In the short-term, continue maintenance replacement of ceiling tiles. Inspect ceiling tiles and replace as necessary where damaged and failing due to sagging. The long-term solution would be to replace the ceiling with newer non-sagging or tegular edged tiles. Note: adding cooling to the spaces will also reduce the amount of humidity present in the building that typically causes sagging over time.
- Floors:** Provide continued maintenance of existing floor and consider replacing the sheet carpeting with a more durable carpet tile that allows for selective replacement when tiles get damaged or stained.
- Classroom Doors:** Continue door maintenance to keep them in good working order. Repair any undesired blemishes and refinish doors in need.

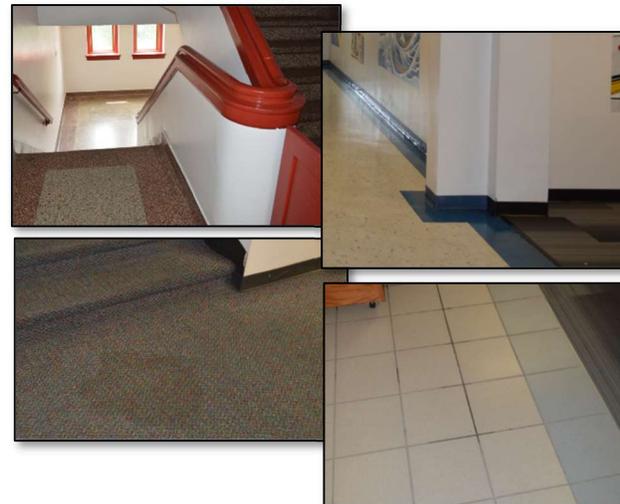
- **Floors General:** Terrazzo floor in the corridors of the oldest portion of the building is covered in most location with carpet tile. The terrazzo remains uncovered at the stair well and the building addition has Vinyl composite tile coverings still in good condition. The older VCT gets it can separate, shrink and crack with humidity and temperature swings. Portions of the second floor corridor have older sheet carpeting that is showing fatigue from use. Ceramic or Porcelain tile is installed at the main entrance to the school. The tile grout is showing some staining that is difficult to correct without grinding out the grout and re-grouting the tile. Regular cleaning and sealing of older grout installations are required for this type of flooring.

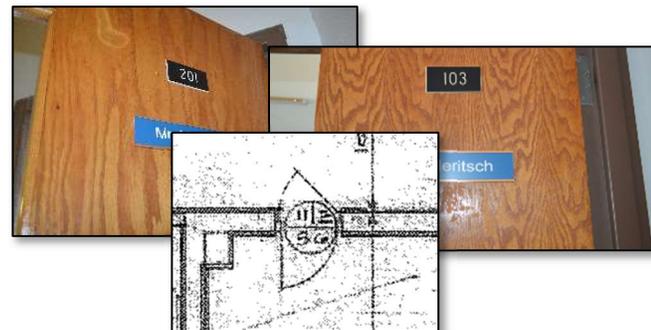
- **Classroom Doors:** Wood narrow vision lite classroom doors are well maintained with some blemishes and worn finish in select locations. All doors observed have hollow metal frames in good condition. The doors and frames located in the original school would have been wood and were replaced during the 1983 renovation to hollow metal frame and solid core wood with narrow vision lite.

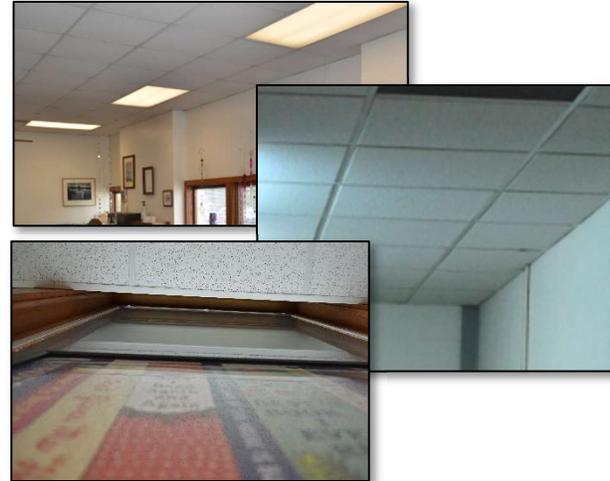
- Classroom Ceilings:** 2X2 Acoustical Ceiling tile generally intact with missing tiles in select locations observed. Some ceiling tiles show sagging in the center causing the corners to curl upward from prolonged exposure to humidity in unconditioned spaces. This is typical with older products with standard square tile edges. In select rooms newer 2x2 ceilings have been installed with tegular edges which are more durable and can withstand prolonged exposure to humidity. At the perimeter windows in the original school the ceiling drops below the head of the window.

- Classroom Ceilings: The ceiling tile is recommended to be replaced on a scheduled program and full classrooms are recommended to be replaced at a time. The new tile should be a 5/8" or 3/4" non sag tile or tile with a tegular edge. Tiles removed from a classroom in good condition can be repurposed to replace ceiling tiles in other rooms in poor condition until such time that room is scheduled for replacement. This will ensure uniformity in the ceiling tile replacement.

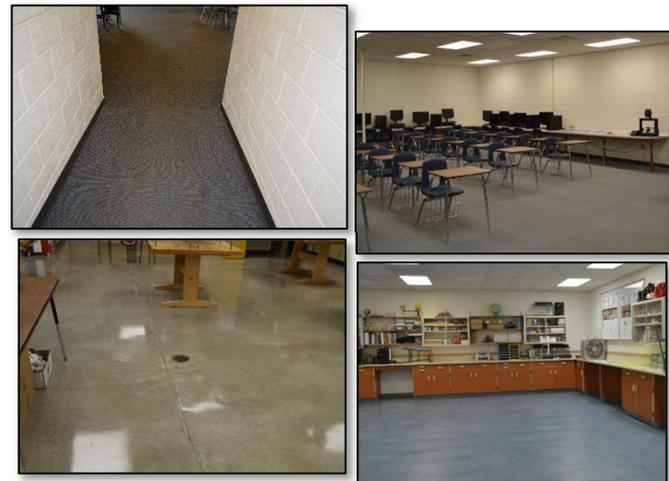
- Classroom Floors:** Most of the classrooms have sheet carpeted floor coverings. Some of these are older and show signs of wear and stains. Carpeting requires more frequent cleaning and with sheet products damage to the carpet is not easily repairable. The carpet tiles in the corridors are more durable and allow for select replacement if damage or stains occur. In lab locations there appears to be a homogenous epoxy floor covering and in the art room there is polished concrete which are very durable but requires polishing maintenance.

- Classroom Floors: it is recommended to replace the sheet carpeting with a durable carpet tile. If it is desired to return to a hard-flooring condition, the recommendation is to install a high traffic durable vinyl tile system requiring lower maintenance.

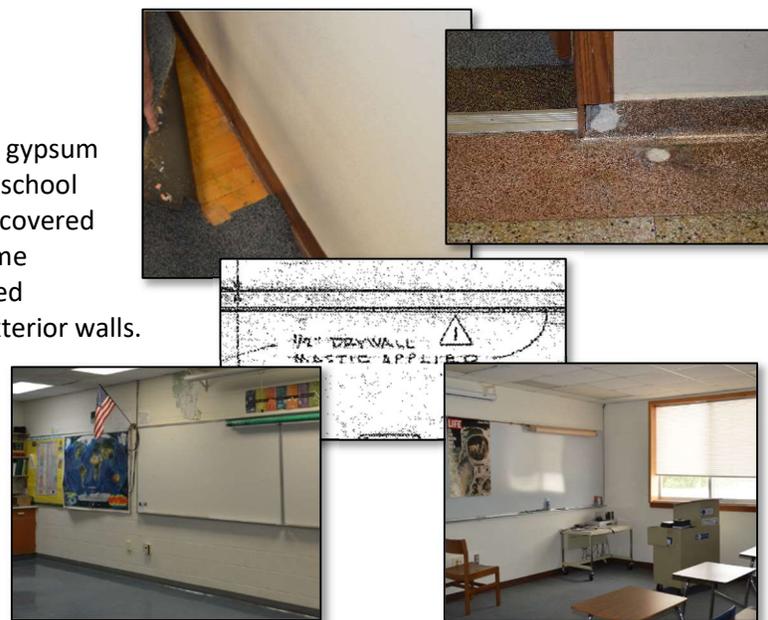
- Classroom Walls:** The walls are predominately painted gypsum board wall coverings in most classrooms. The original school was likely furred or direct applied lath and plaster but covered with adhered drywall during the 1983 renovation. Some classrooms have a mix of framed gypsum board covered partitions and exposed masonry at the corridor and exterior walls. The lab, art and music spaces are painted exposed concrete block. Masonry walls provide durability and inherent noise reduction.

- Classroom Walls: Consider repainting individual classrooms only if necessary or if there is a desire to change the environment.
- Casework: Replace casework as necessary with uniform casework for ease of maintenance and attic stock inventory management.

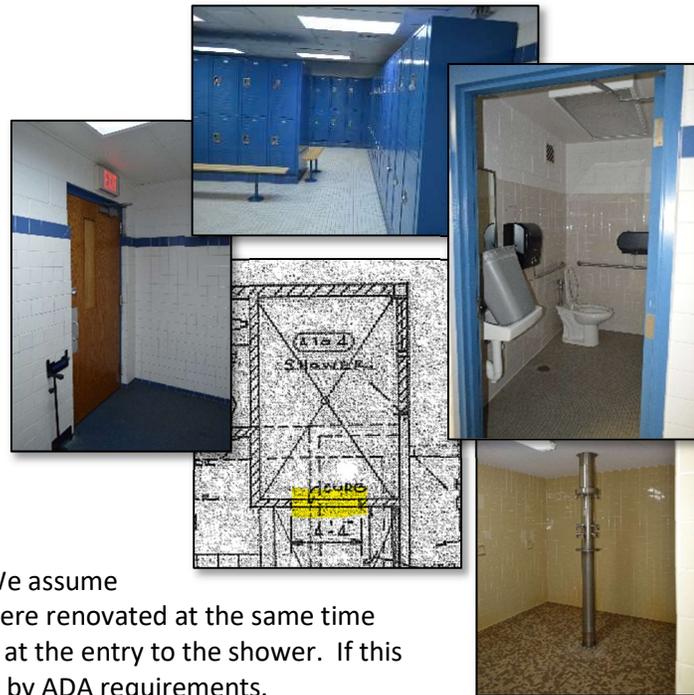
- Boy's/Girl's Locker Rooms:** The boy's locker room is in relatively good condition. The wall have a glazed porcelain tile wainscot, mosaic tile floor and relatively new lockers. The locker room has an accessible toilet room. The shower room has (2) center post gang style showers. This does not allow for privacy of the occupants and many users may choose to forego a shower without the privacy of individual showers. The shower controls are hand operated and there is no special accommodations for accessibility.

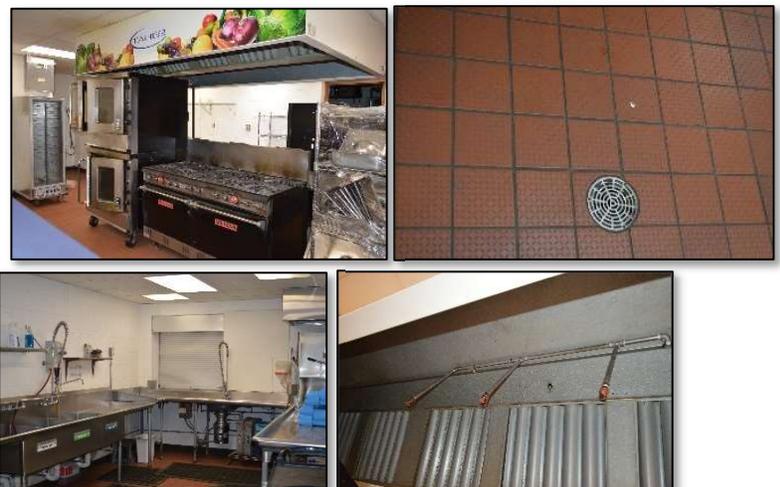
- Kitchen:** the kitchen was added in the 1983 addition and renovation project. It has the appropriate suppression system over the cooking equipment. The textured quarry tile floor is beneficial for anti-slip conditions.

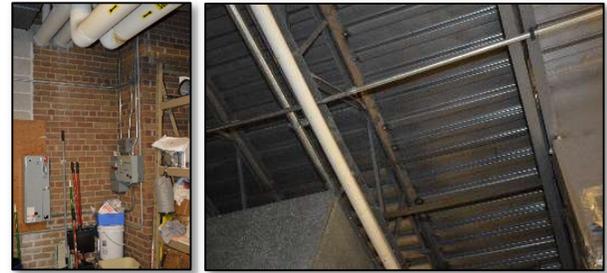
- Mechanical room:** The main mechanical room added in 1983 houses the main mechanical equipment. Some of the major fuel fired equipment is housed in a fire rated room with a rated ceiling. The water service room below the wrestling room has been taking on water especially during rainstorm events. This indicates a failure in the wall system. Water is entering the wall cavity and not getting wept back to the exterior indicating insufficient or clogged weeps in the cavity wall system. This also could explain the cracking in the wall above in the wrestling room.

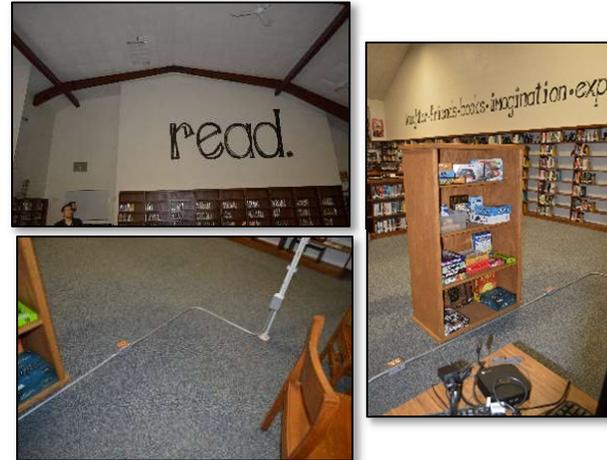
- Library:** The Library is a nice large space framed with mass timber frames. The original ceiling would have been the exposed wood roof deck. For some reason it has been covered with a drop in ceiling obscuring the wood deck and the full depth of the timber frame.
- There are electrical receptacles run in conduit above the floor creating a tripping hazard. Casework currently has to be placed at or near these conduit runs for safety control.
- The floor covering is a sheet carpet and is showing signs of wear.

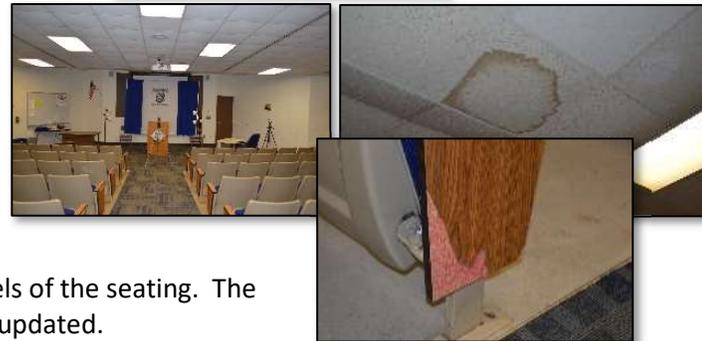
- Lecture Hall:** The lecture hall has soft tiered seating with carpet tile floor covering at the aisles and the head of the room. There is water damage on some of the ceiling tile that isn't apparent if it is due to an active leak or not. The laminate on the seating is damaged on several end panels of the seating. The technology in the lecture hall is dated and could use being updated.

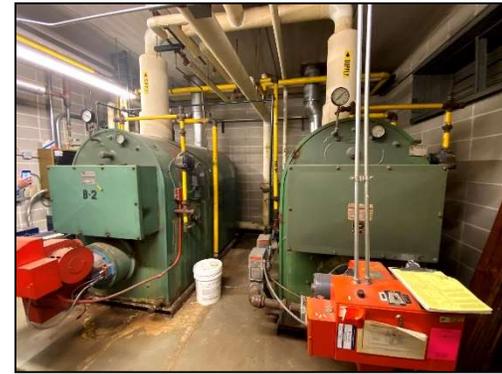
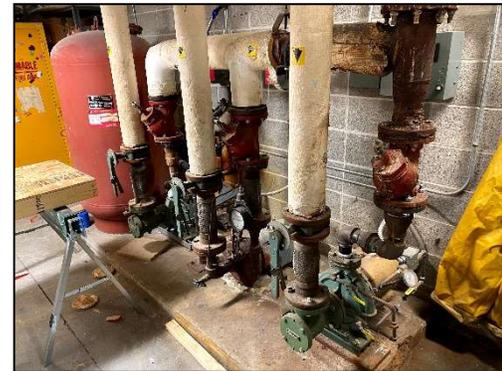
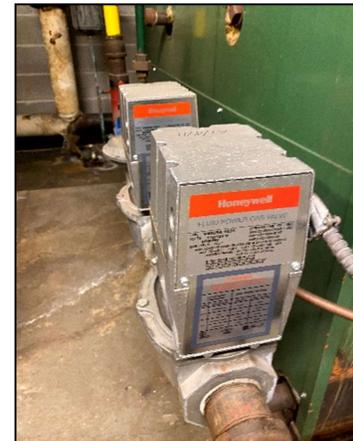
- Hot water piping was insulated throughout the facility. The insulation was in average to poor condition. The majority of piping distribution appears to date to the 1983 addition with some older piping from the 1959 addition still used in the West portion of the building.

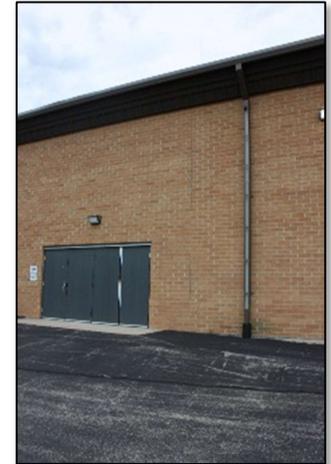
- Exit 11:** this door is the emergency exit from the boy's locker room built in 1993. Although not originally on the drawings, this serves as the second exit required by code from the space. The stoop outside of this space is not ADA compliant; however, there is a path of egress provided through the main gym space. An improvement would be to provide a sloped condition from the stoop for access to the public way.

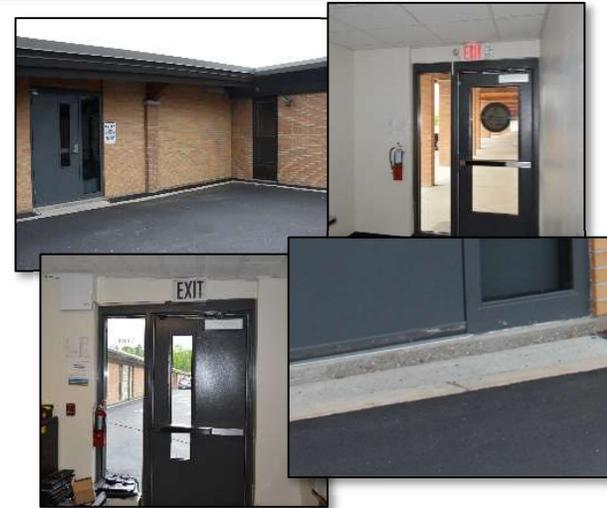
- Exit 18 & 19: These doors were installed with the administration and classroom addition in 1987. They are insulated steel, with insulating glass, hollow metal framed doors. It is well protected from elements and is in good condition. Door 18 facing west has a 4" step down at the door threshold. This prohibits this exit from being an accessible means of egress.

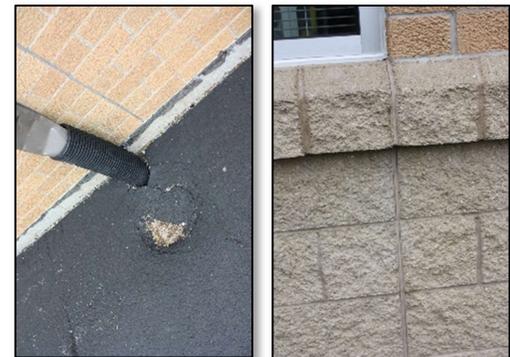
- Control Joints:** There are control joints on the buildings in appropriate locations. Some of these have begun to separate from the masonry. This may be due to the incorrect sealant type being used relative to environmental conditions or more likely compatibility with adjacent materials.

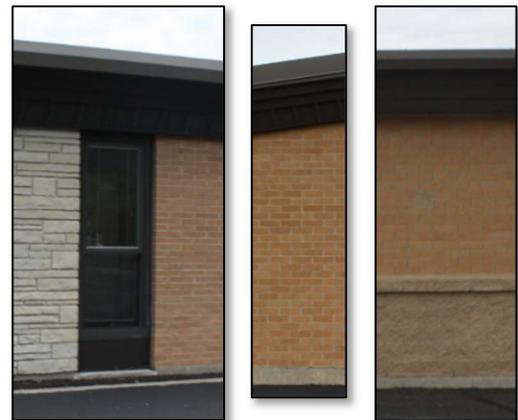
- Walls:** There are three types of masonry walls.
- TYPE A:** Brick or stone masonry over CMU structural backup wall. There is no cavity in this wall, so it is considered a mass masonry type wall. The walls are also furred on the inside. This wall is built on a CMU foundation.
- TYPE B:** Brick cavity wall with CMU backup and rigid insulation in the cavity.
- TYPE C:** Brick and split faced CMU cavity wall with CMU backup and rigid insulation in the cavity.

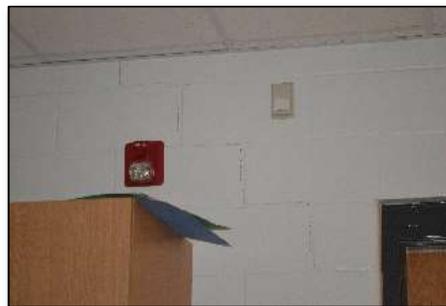
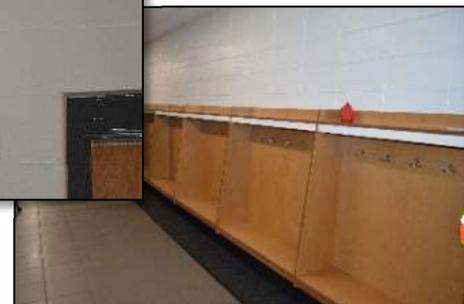
- **Walls General:** Corridor walls are painted CMU which is a durable structural material. There were stress cracks observed in at least one location. This may not be concerning, however should be investigated to verify cause and extent of cracking.

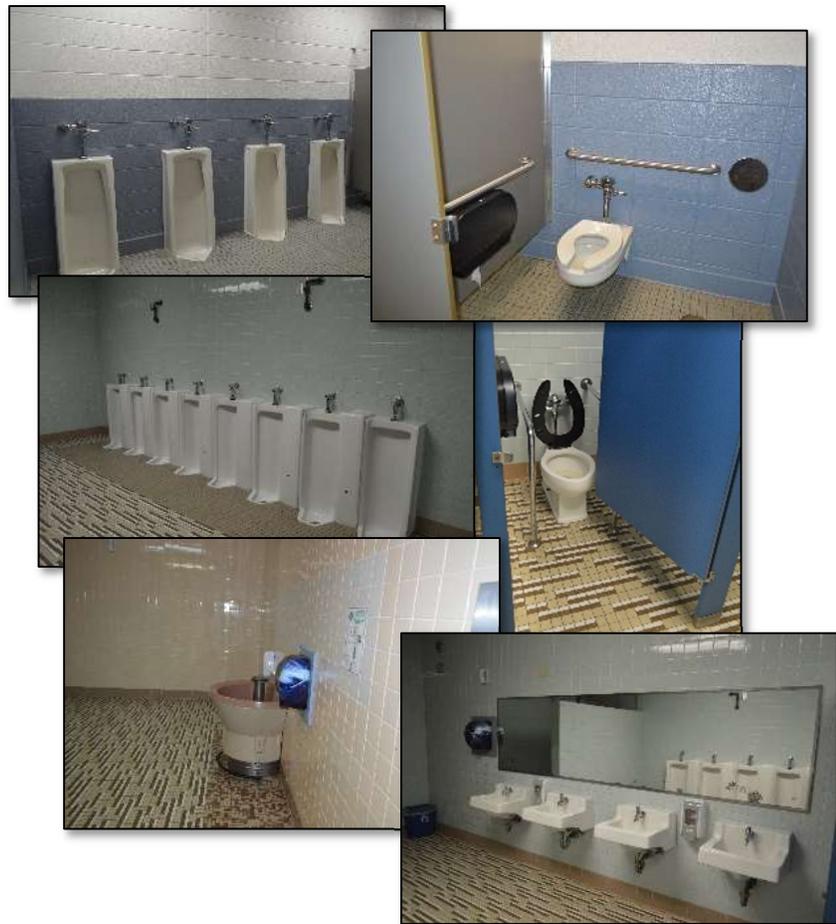
- Boy's Restrooms:** The boys restrooms have button flush floor mounted urinals without privacy screens. The toilet stall in the 2005 and 1993 bathrooms have an accessible stall; however, the accessible stall in the 1967 toilet room is only an ambulatory style stall. The mosaic floor tile looks well maintained. Typically, with floor mounted urinals and tile flooring, there can be an issue with odors associated with the grout taking on extra moisture around the base of the urinals. The sinks are also push-button type faucets for water savings. There appears to be newly installed hand dryers. Another rest room has a foot operated wash fountain.

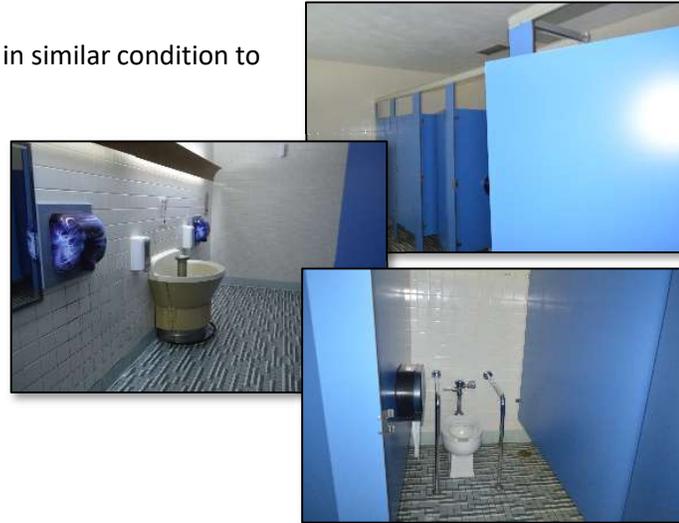
- Girl's Restrooms: The girl's restroom was observed to be in similar condition to that of the boy's restroom with the same amenities.

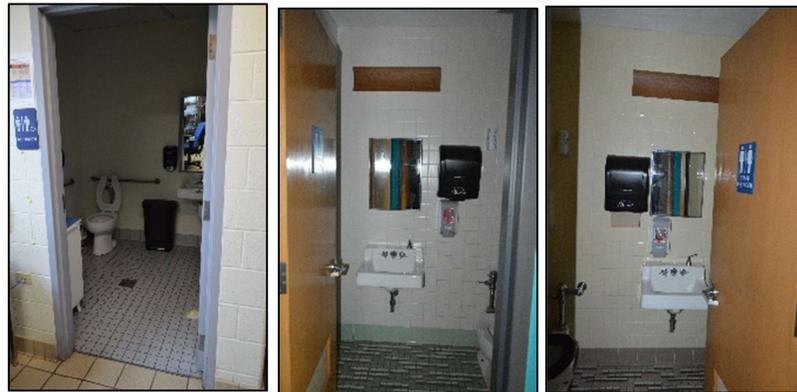
- Staff and Unisex Toilet rooms: The staff toilet rooms are unisex toilet rooms and are under sized to be accessible. There are fully accessible unisex toilet rooms in another location in the building.

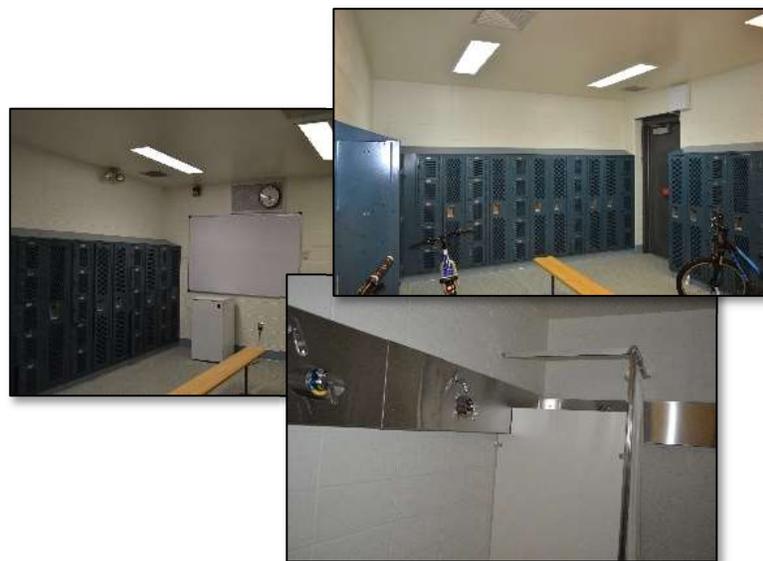
- Boy's/Girl's Locker Rooms: Lockers are in good condition. An alarmed door was added to the boy's locker room specifically as a second exit from the space to be code compliant. The mosaic tile floor is in good condition as well. The shower room has perimeter mounted shower heads but only one privacy enclosure.
- Note: the girl's locker room is assumed to be in similar condition as the boy's locker room.
