Peshtigo School District

Facility Study
August 3, 2020

Re: Preliminary Facility Study and Report

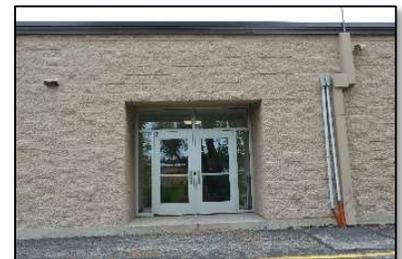
- Exit 7:** Very similar condition to exit/entry 5, the same issues apply to this entry. The sweep at the bottom of the left leaf is damaged, and the sealant at the base of the sidelights may be preventing the system from properly weeping.

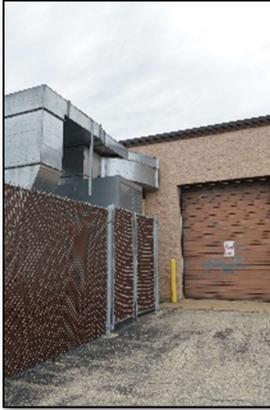
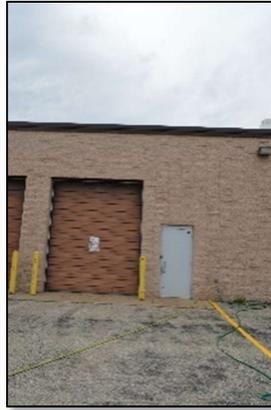
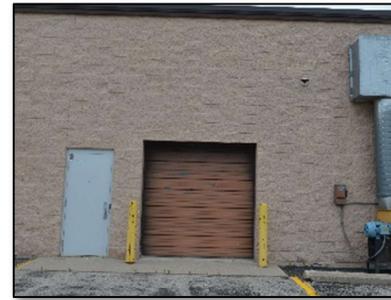
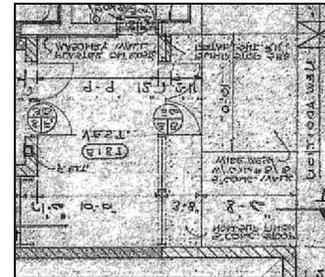
- Wood Shop Overhead Door & Service/Exit 8: The insulated overhead door has peeling paint. The hollow metal service/exit door is in good condition.
- Metal Shop Overhead Doors & Service/Exit 9: The insulated overhead doors have peeling paint. The hollow metal service/exit door is in good condition.

- To improve thermal transfer rates, it is recommended that the older aluminum framed systems are replaced with new thermally broken aluminum storefront systems with Low E tempered insulated glazing. Hollow metal doors should be inspected for surface rust and repainted if necessary. Inspect and replace weather stripping systems. Overhead door should be repainted and inspect the weather-stripping.

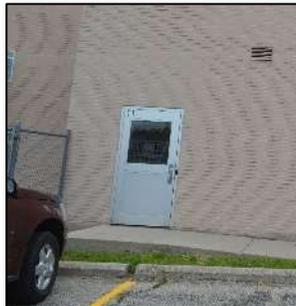
- Entrance/Exit 10: aluminum storefront entrance with a deep EFIS overhang. There are breaks in the sealant.
- Exit 11: This exit appears to be rarely used. The painter overpainted the aluminum frame and perimeter sealant.

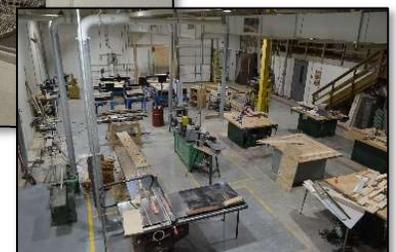
- Wood Shop:** The wood shop space is well lit and fairly clean. There appears to be enough space for student function and interaction. At the mezzanine level a louver in the side wall had a screen displaced at the wood shop side. The function of this louver is unclear and should be investigated to be sure dust and fumes are not being transmitted to another space.

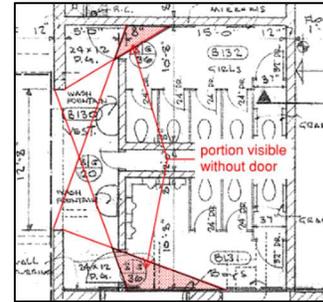
- Privacy Line of sight:** it is important to note the configuration of the alcove to the restrooms provide an obscured line of site if the restrooms had no doors on them (image to the right from '83 drawings). It could be feasible to remove the doors providing a touchless entry to the restrooms. Similarly, the renovated restrooms in the original building exhibit the same qualities.

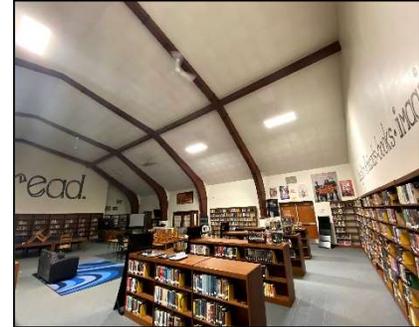
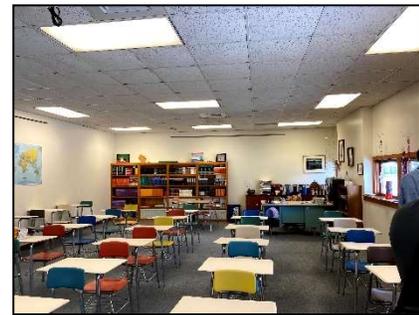
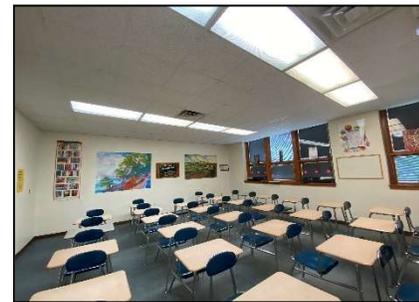
- The existing lighting controls are the original manual control wall switches with 1, 2, 3 or 4 scenes depending on the size of the space. These existing scene selectors help with zone control within each space to illuminate or cut lighting to the front learning area. Automatic controls in the form of occupancy or vacancy sensors should be considered to manage the lighting when spaces are not being used.

- Exterior lighting is minimal around the building represented by mostly wall sconces.

- Replace the existing fluorescent lighting with new LED fixtures with onboard wireless lighting controls (occupancy and daylighting). Replace the wall switches with new wireless programmable scene control switches.

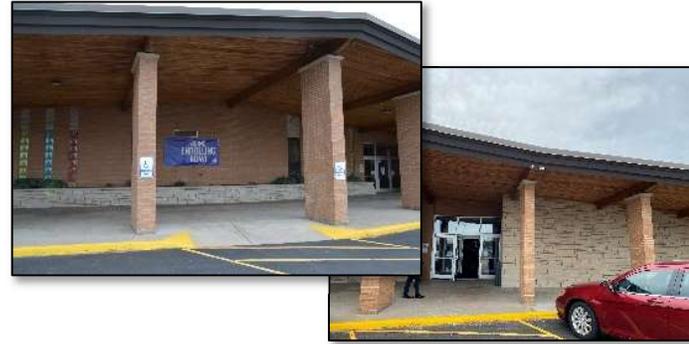
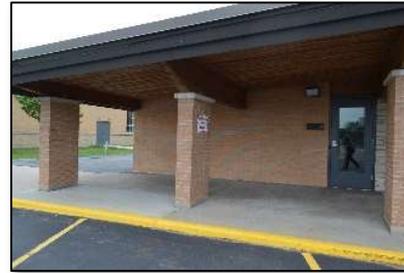
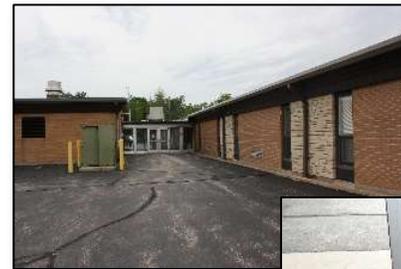
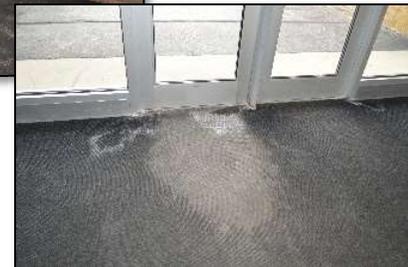
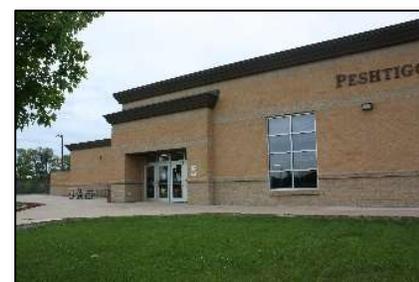
- **Entrance/Exits 5, 6, 7 & 8:** These aluminum framed entrances and exits were installed in 2005 with the school additions. These are aluminum framed entrances and are likely thermally broken frames. The entrance and exits installed in 2005 are in good condition and no immediate concerns are anticipated.

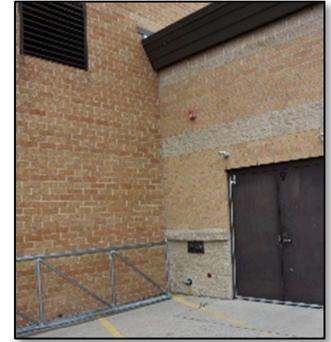
- Exit 9:** The kitchen service door is a double insulated steel, hollow metal framed door and is in fair condition. The finish on the door leaves and frames are showing its age as well as some light damage due to the nature of its use as a service door and where deliveries are made.

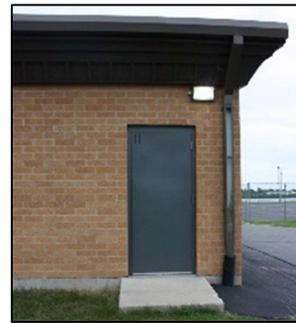
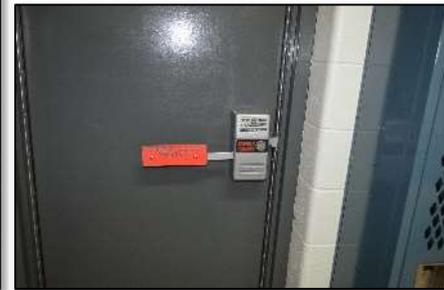
- Exit 11:** this door is the emergency exit from the boy's locker room built in 1993. Although not originally on the drawings, this serves as the second exit required by code from the space. The stoop outside of this space is not ADA compliant; however, there is a path of egress provided through the main gym space. An improvement would be to provide a sloped condition from the stoop for access to the public way.

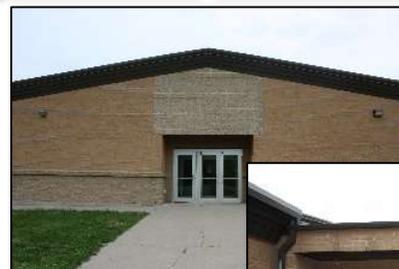
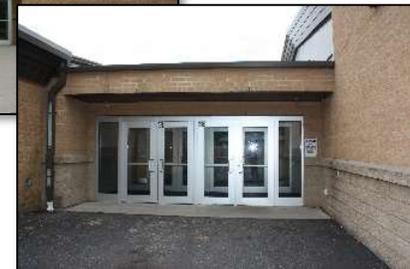
- Exit 12 & 13:** This aluminum framed entrances and exits were installed in 2005 with the school additions. These are aluminum framed entrances and are likely thermally broken frames. The entrance and exits installed in 2005 are in good condition and no immediate concerns are anticipated.

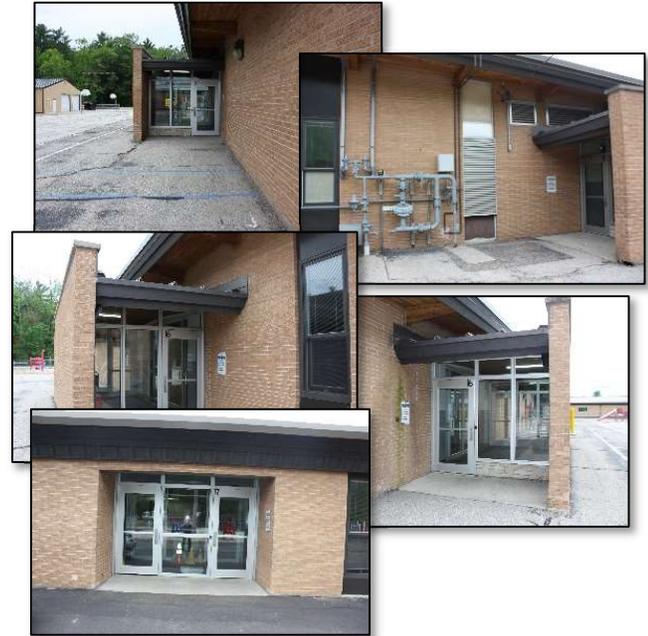
- Exit 15, 16 & 17: The original entrance doors to the school appear to have been replaced from the original single pane aluminum framed doors. It is unclear as to when they were replaced or if the frames are thermally broken as new installation would be. Observed light infiltration from the inside which would indicate significant air leakage.

- **Exit Doors:** In the Short term, Inspection of all exterior door seals, sweeps, thresholds and weather stripping should be conducted and failing items should be replaced. Clean up and re-paint the few doors that are rusting or corroding to halt the deterioration. Inspect all perimeter sealants at each door and replace any failing sealants with a product compatible to all adjacent materials. Bi- annual inspections of sealants is recommended to be part of a maintenance plan. Repaint fading insulated metal doors for improved appearance. In the long term, consider replacing aluminum storefront systems that are not thermally broken with new storefront entry systems for better thermal performance.

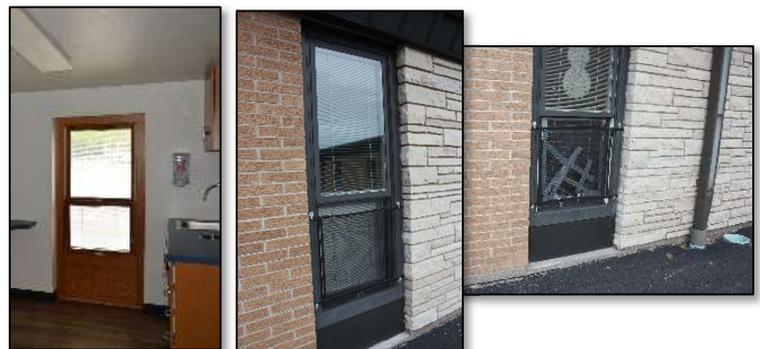
- 1967 building has replacement aluminum clad wood single hung windows. The sashes have double paned glass with between the glass blinds. The perimeter sealant is in good condition where observed. A mesh safety screen has been installed over the operable light and several screens are damaged. One window has a damage exterior pane of glass.

- **Windows General Conditions:**
- **1967-'87:** It is recommended to inspect the perimeter sealants and replace any failing sealants with a product compatible to all adjacent materials. Replace broken panes of glass along with any failing screens. Keep an eye on the between the glass blinds for UV deterioration in nylon cording in the horizontal blind construction

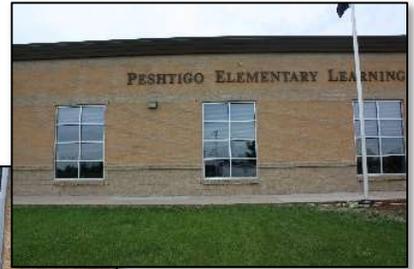
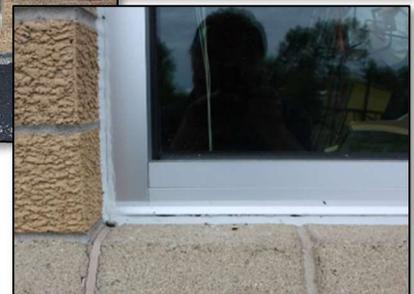
- The perimeter sealant is failing around some of the windows. This was particularly observed at the 2005 addition. This is potentially due to an error in the installation process or the sealant is incompatible with the adjacent materials.

- **2005:** It is recommended to inspect the perimeter sealants and replace any failing sealants with a product compatible to all adjacent materials. The perimeter sealant is failing around some of these windows.

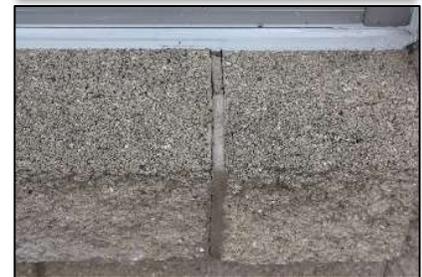
- Stone and masonry sills: It was common to grout vertical mortar joints at window sill that deploy masonry of multi-piece stone sills. The mortar in these conditions typically fail as the sill move differently and by nature take on more water than a vertical wall surface.

- Bi-annual inspection of perimeter sealants at window openings is recommended to be part of an ongoing maintenance plan.
- **Stone and masonry sills:** Grind out and replace the vertical joints a minimum of 3/4", and install an elastomeric sealant colored to match the mortar. The finished look of the mortar is a concern, fine aggregates matching the aggregate in the aggregate in the mortar can be imbedded in the surface of the sealant to provide a similar look to the mortar.

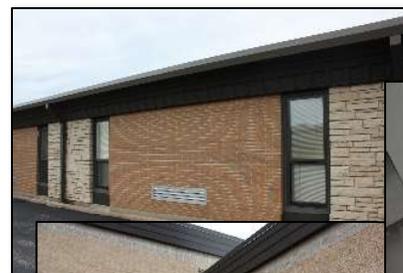
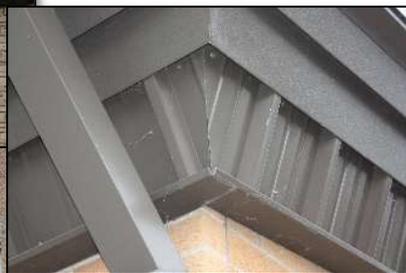
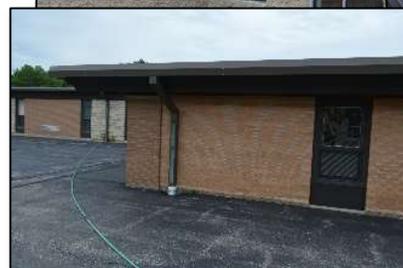
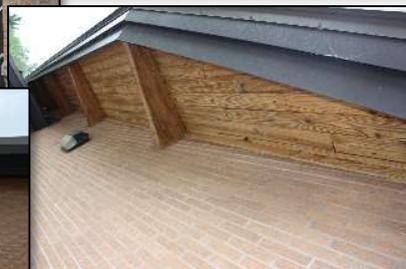
- Overhangs: The overhangs on the original building were redesigned and installed in conjunction with the 1987 additions. They feature some integral gutters and some standard hung gutters. There are several locations where the system is leaking and causing staining on the masonry walls (see wall assesment section). The overhangs and roof edges at the 1993 and the west wing of the 2005 addition project are similar in character and have standard fascia mount gutters. The esposed wood decking is well maintained and supported by timber framing.

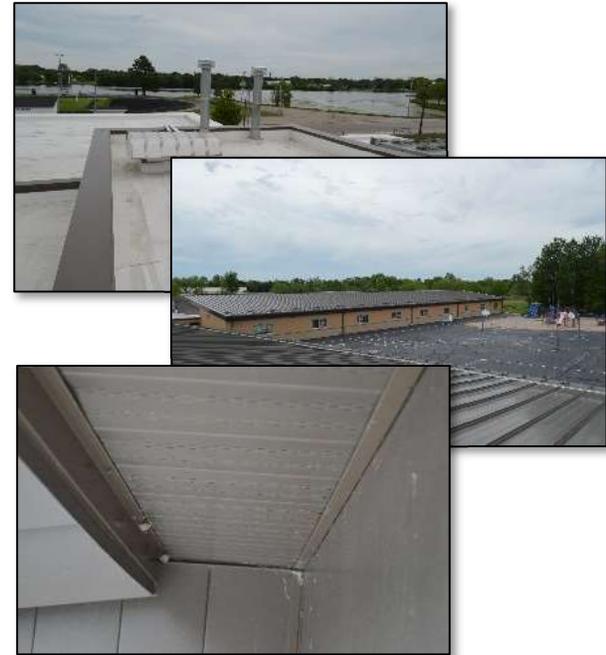
- Roofing:** Most of the roof covering is a standing seam roof over rigid insulation and wood timber or Tectum deck on the '67-87'. The 1993 building addition is a steel framed building with steel purlin framing and batt insulated roofing with matching standing seam roof. The east portion of the 2005 additions is a flat metal deck roof with rigid insulation and a white TPO roof covering fully adhered. The west portion is a standing seam roof to match the existing roof on wood trusses and attic type insulation. This roof system is vented with soffit intakes and ridge vent exhaust. No roof leaks were observed at this time. The standing seam roof is typically a very durable construction when properly installed and usually has a long-life span.

- **Roofing:** Roofing is currently in good condition; no leaks were observed during the field survey visit. Aside from the gutter and downspout included in the overhangs section above, there are not many roofing concerns. Verify there are no active leaks in either of the different roof constructions on the building. It is recommended to do a bi-annual inspection of the roofing systems. The flat TPO roof should have an infrared leak detection scan in conjunction with the roofing inspections. This may be deferred to a three-year schedule unless a leak is apparent.

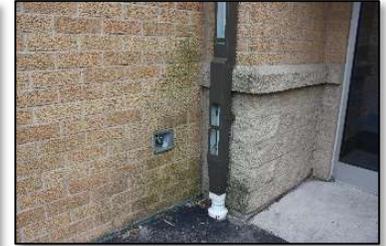
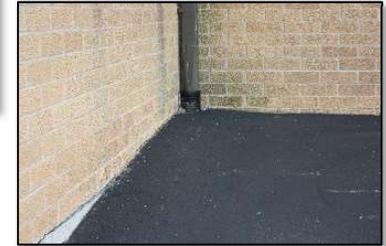
- The walls are typically in very good condition. There are weeps installed in the cavity walls with through wall flashing. There is algae and mildew staining from leaking downspouts.

- Walls: Cursory bi-annual visual inspection of masonry is recommended. At minimum, it is recommended for an extensive inspection for crack in mortar or masonry unit failures every five years. This can prevent any major failure in the building envelope even when the envelope system is as robust as this building. Clean the algae and mildew staining with appropriate cleanser in conjunction with the downspout repair/replacement. This can be done with a mild detergent, scrub brush and potable water to prevent damage to the masonry and mortar.

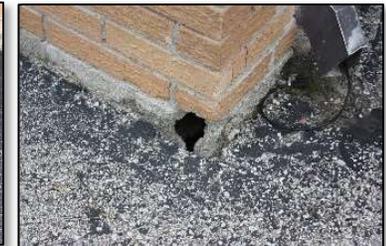
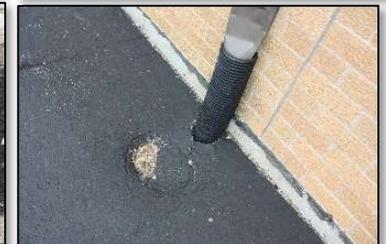
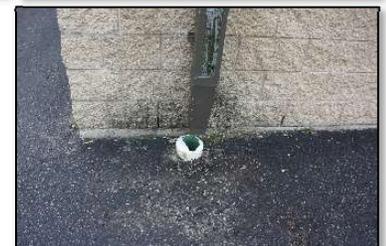
- Perimeter Foundation & Drainage conditions:
There is a hole in the wing wall of the exit 16 vestibule due to erosion at the foundation. This hole is taking on water and potential for damage from trapped water and it is freezing. The underground drain tile is failing around the connection points to the downspout termination. Causing the soil to be undermined leading to sink holes at the downspout connections.
- Asphalt was filled in around the perimeter of the original '67 building encapsulating the exterior underground storm drain. This may have been done to eliminate the landscaping strip along the building to reduce maintenance.

- Perimeter Foundation & Drainage conditions: grout the hole in the foundation CMU to prevent further damage to the below grade foundation system.
- It is recommended to remove the asphalt where it fills in between the concrete curb and the exterior wall at the 1967 building. It would be better to install 3"-4" of clear 2" minimum stone to prevent the need of landscaping maintenance.

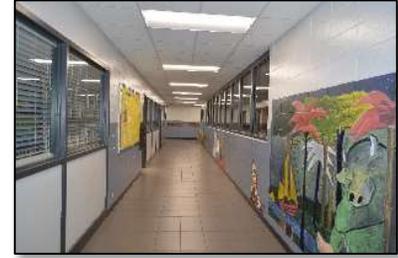
- **Ceilings General:** Corridor ceilings appear to be a newer acoustical ceiling tile (ACT) product or a tegular edge tile, in some locations, which should be more durable and resist humid conditions better than the older ACT technology.

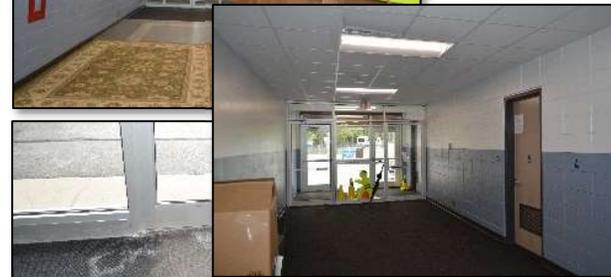
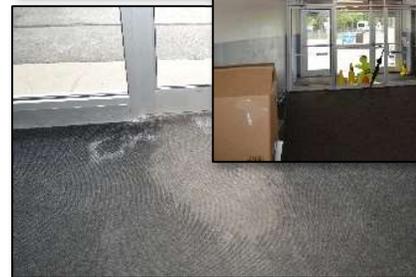
- **Floors General:** The corridor floors have several different floor coverings. Some of the floors are covered with ceramic tile and some are sheet carpeting and carpet tile. The sheet carpeting and carpet tile are covering an unknown substrate. The 1967 building could potentially have asbestos containing tile and it should be verified before any removal of floor coverings. There is damage to the sheet carpet floor covering at the connector to the 1993 addition.

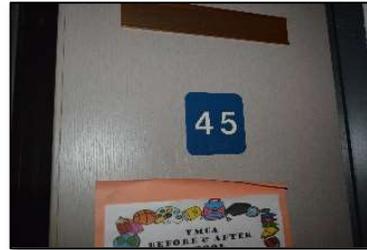
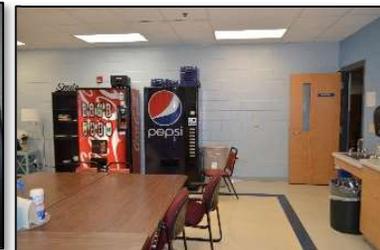
- Classroom Doors: Classroom doors are in good condition. Some of which have been painted, but most of them are varnished natural finish.

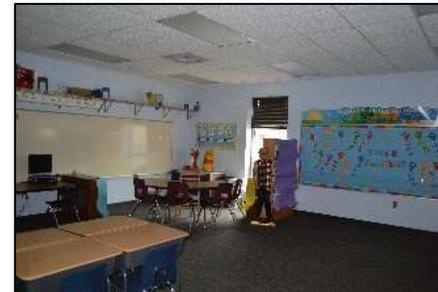
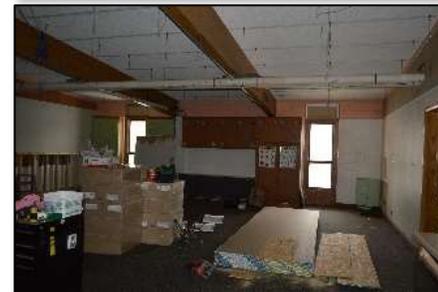
- Classroom Ceilings: some of the classrooms have a 2X4 ceiling in which the ceiling panels have been replaced with a newer ceiling tile. This is evident by the absence of sagging in the center of the tiles and curling at the corners. Some of the classrooms have a tegular edge tile with a center score mark to resemble a 2X2 ceiling tile. A large portion of the classrooms in the '67 building are under renovation and the ceilings are taken down.

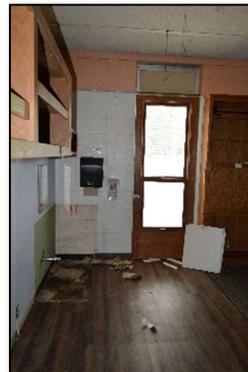
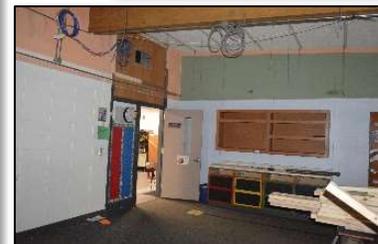
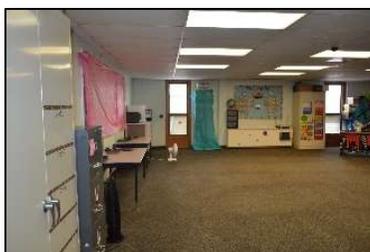
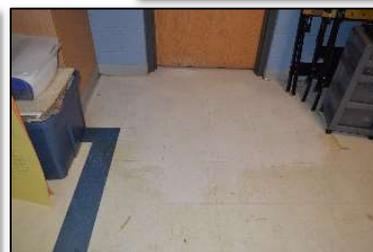
Classroom Floors: It is assumed that the classrooms undergoing renovations will be getting a new floor covering. There are sheet carpet and carpet tile floor coverings in some of the other classrooms. There are also classroom spaces with Vinyl Composite Tile (VCT) floor coverings. Some of the old VCT flooring has separated and have gaps which can happen with humidity in a building.

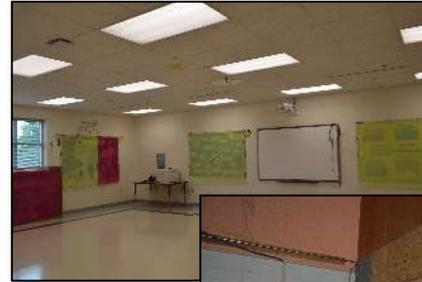
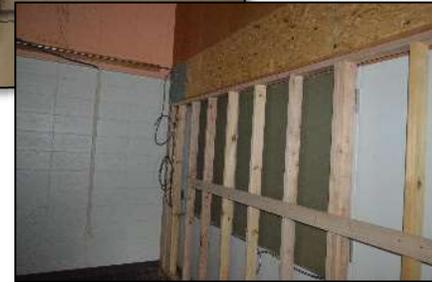
- Classroom Walls:** most of the classroom walls are painted CMU. There are some non-bearing partition walls that have gypsum board covered framing as well as the movable partitions being encapsulated during the current renovation project. The areas being renovated are not part of this condition assessment. CMU walls are durable and provide an excellent sound barrier from other occupied spaces.

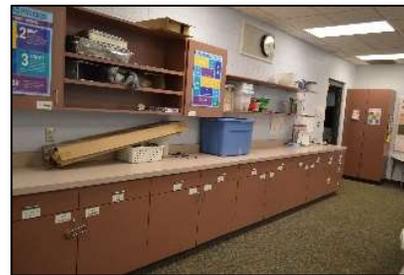
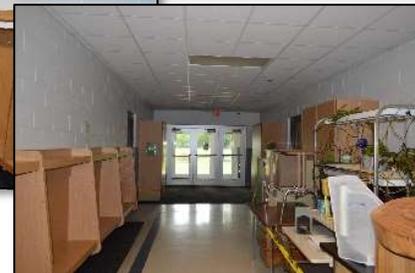
- Casework:** casework in the classrooms vary depending on the age of the construction. Some of the older casework is plastic laminate and in fair condition; however, they do not possess locking hardware to keep materials secure. Even some of the newer casework that is a wood grain look plastic laminate does not have the capability to be secured. The corridor has built-in-place coat hook and bench wall hung casework with a carpeted boot storage underneath. There are also storage cabinets near the exit to the playground. This casework appears fairly new as it is in good condition.

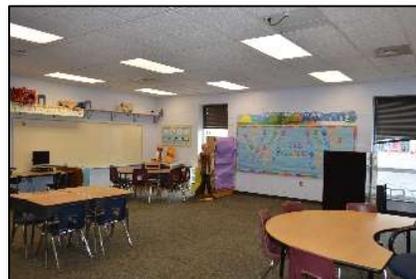
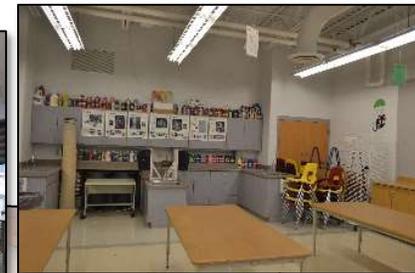
- Furnishings:** there are different types of student seating in the school. Most locations have individual seating available in the form of individual desks, individual storage table and chair or configurable collaborative individual table and chair. Lab and art room spaces have two student table and chair furnishings.

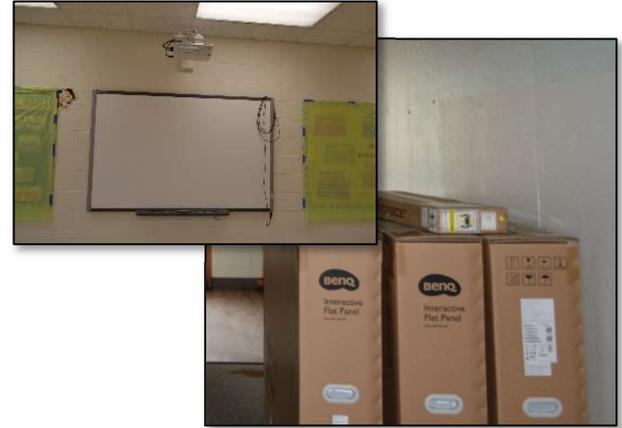
- Technology:** Smart boards are included in most of the classrooms, the classrooms under renovation may have this equipment taken down and being stored during construction. It is also apparent that some of the classrooms will be receiving interactive flat panel technology.

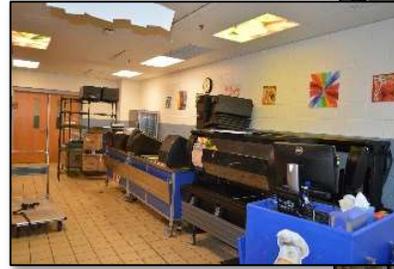
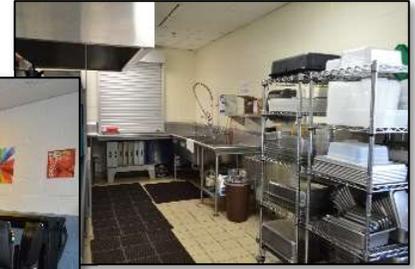
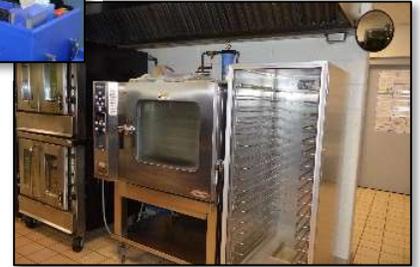
- Kitchen:** the kitchen has a tan quarry tile flooring with dark grout which could be a long-term issue if regular cleaning and resealing of the grout is not kept up on. This is prevalent near the dish washer where significant staining has occurred under the stainless-steel equipment. all the work surfaces are stainless steel and provide clean work surfaces when well maintained.

- Kitchen: The kitchen has a tan quarry tile flooring with dark grout which could be a long-term issue if regular cleaning and resealing of the grout is not kept up on. This is prevalent near the dish washer where significant staining has occurred under the stainless-steel equipment. All the work surfaces are stainless steel and provide clean work surfaces when well maintained.

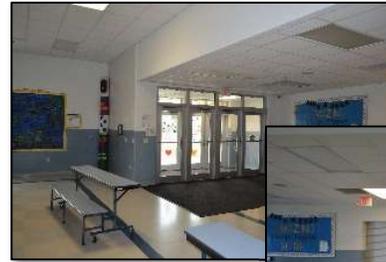
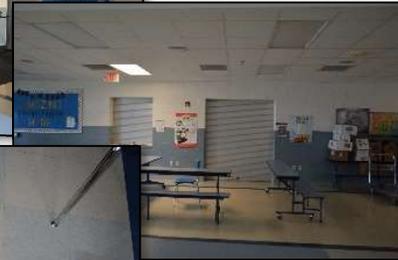
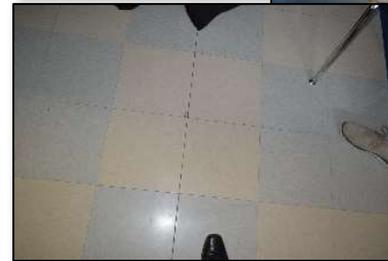
- Multipurpose Gym /Cafeteria:** The flooring in the multipurpose room, built in 2005, is showing signs of uncharacteristic fatigue. There is significant tile separation and cracking along control joints. It is concerning why the floor slab is moving that much.

- Multipurpose Gym /Cafeteria: Replace the floor covering and accommodate for the slab movement with planned control joints. An epoxy floor covering could work nicely here and provide an opportunity for a selective design or theming.

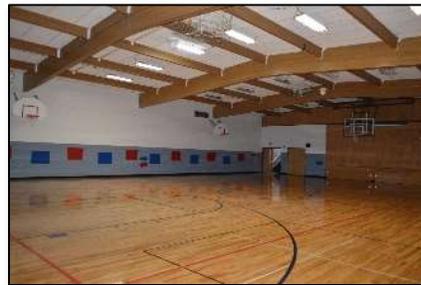
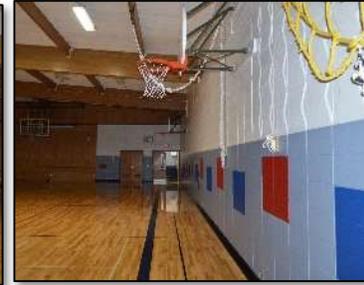
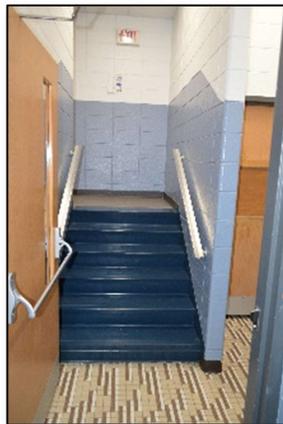
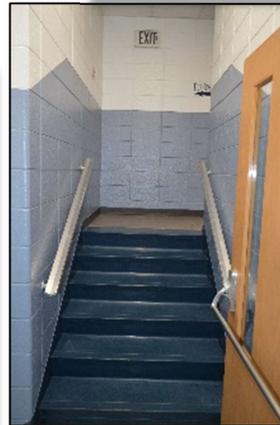
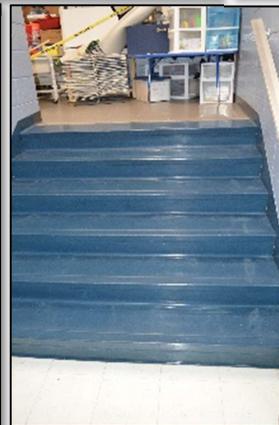
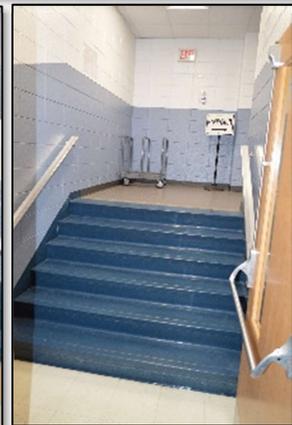
- Gymnasium 1967:** The original gym is smaller than the 1993 gym and originally served as the cafeteria. The performance stage is also smaller than the stage in the '93 addition. This gym is also not accessible as it is sunken below the main school floor level approximately 28". The area previously serving as the school kitchen is currently used for storage.

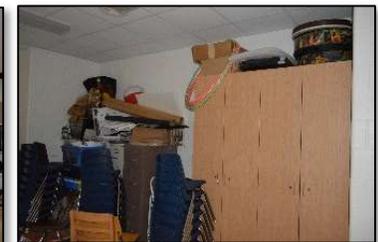
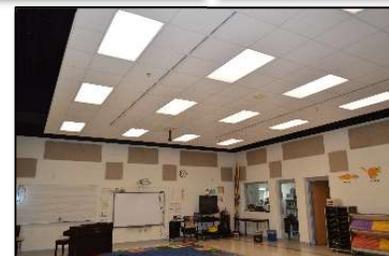
- Music Room:** The music room in the 2005 addition is adjacent to the multipurpose room. It is a large space with hard surface flooring, exposed masonry walls and standard acoustical tile ceiling. The acoustics in the space are likely difficult to control with the hard surface floor. Acoustical panels that were not noted in the original construction plans were likely added to help control sound.

- Music Room: A soft floor covering such as carpet tile will help control sound.
- Art Room: it is recommended to have the kiln in a separate enclosure to control the exhausting and provide added protection from fire or accidental injury.

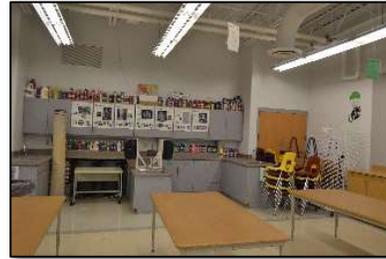
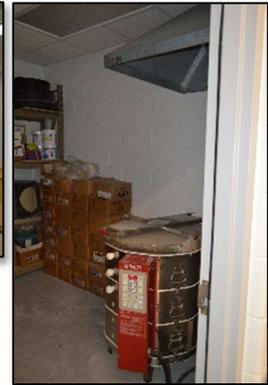
- Art Room: The kiln in the art room is open to the rest of the room. This is not typically the safest or most controlled way of exhausting the fumes and heat from the use of a kiln.

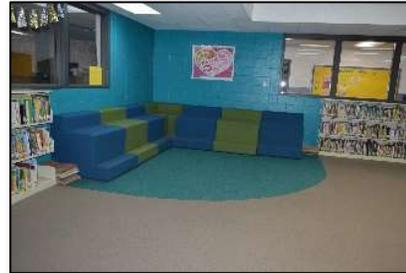
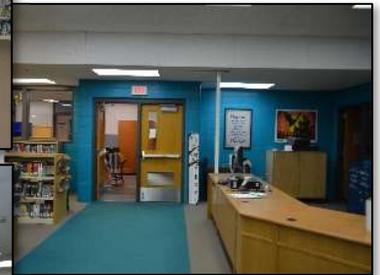
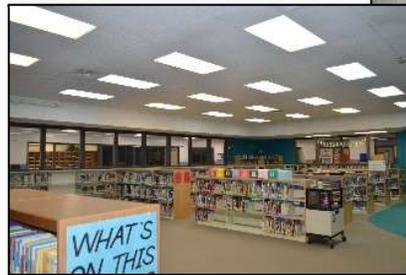
- Library: The Library has sheet carpet in good condition and a 2x2 ACT ceiling system that look relatively new. There is some soft collaborative seating in one corner for group instruction.

- Library: When the carpet needs replacing, consider replacement with a commercial carpet tile as the individual tiles could easily be replaced if damaged or stained instead of complete replacement.

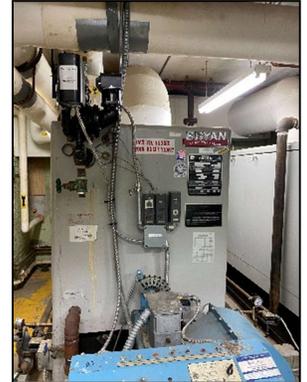
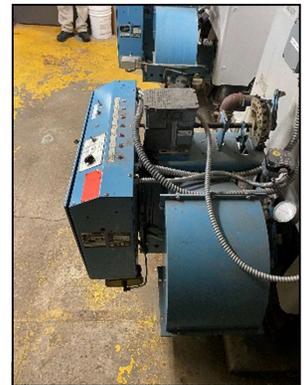
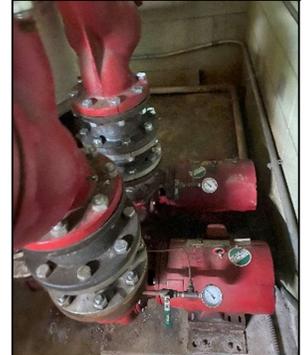
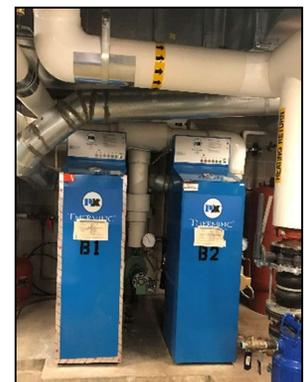
- The main plant serving the original construction and '93 addition consists of two (2) HW boilers from Bryant. The boilers are 2,700 MBH input each and 80% efficient. The boilers were installed in 1993 and are at their expected service life. A future replacement plan should be developed to track this project.

- Highly recommend replacing the entire main boiler plant and distribution piping. Provide two (2) new high efficiency condensing boilers with dedicated primary pumping and two (2) HW distribution pumps with variable frequency drives (VFDs). At the same time, replace the AHU HW heating coils and VAV terminal unit coils with new coils capable of delivering low-temperature HW heating at 135F degrees. This will increase efficiency on the heating plant, save energy and address aging systems.

- Recommend planning for replacement of the secondary boiler plant as the boilers are nearing the end of their service life. Recommend replacing boiler pumps and distribution pumps at the time of boiler replacement.

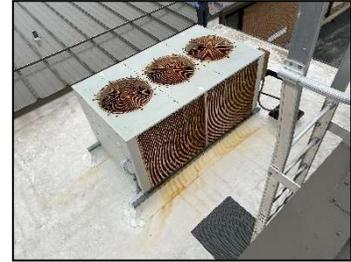
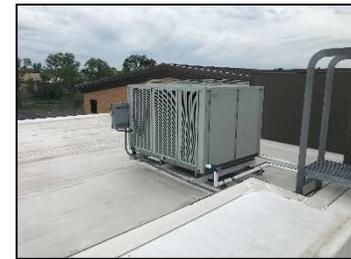
- One (1) split DX condensing unit is located on the roof of the 1993 addition and serves the associated addition's Variable Air Volume (VAV) AHU. This unit is beyond its expected service life and should be replaced. It has already experienced a compressor failure.

- One (1) split DX condensing unit is located on the East roof of the 2005 addition and serves the associated addition's VAV AHU. This unit is in good condition and should last the district for some time with proper maintenance.

- One (1) split DX condensing unit is located on the West roof of the 2005 addition and serves the associated addition's VAV AHU. This unit is in good condition and should last the district for some time with proper maintenance.

- Implement a replacement plan for the AHUs and Condensing units which prioritizes units that are oldest and in the poorest existing condition. Consider replacing the '93 addition equipment as part of the first phase of project work.
- Primary:
 - Provide a chiller and primary pumping system to provide cooling.
 - Replace existing AHUs and unit ventilators serving classrooms with new vertical classroom unit ventilators with dual temperature coils to provide heating, cooling and ventilation to learning environments.
 - Size dual temperature water piping for future expansion capability to serve '05 addition.
 - Provide capability of plant to easily expand to accommodate expansion to serve '05 addition.
- Secondary:
 - Provide split DX cooling for new vertical unit ventilators and new AHU to serve original building interior spaces In lieu of chiller and dual temp distribution.

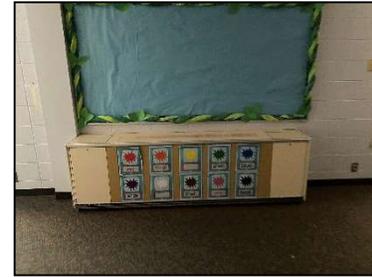
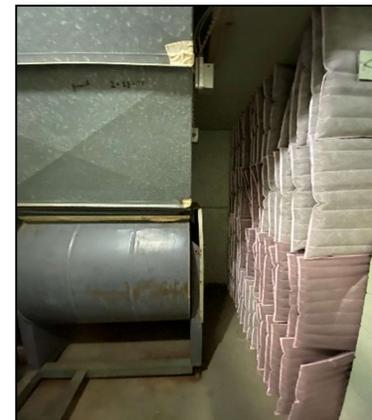
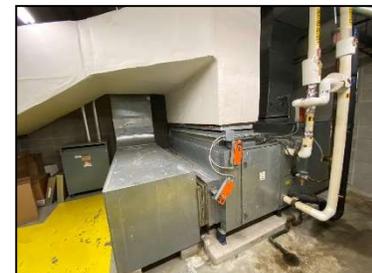
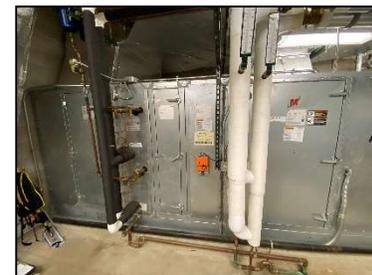
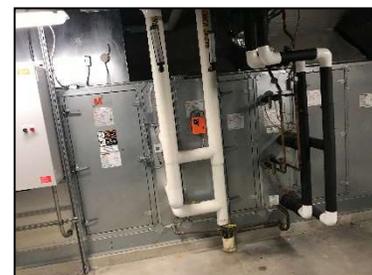
- The interior spaces of the original school are heated and ventilated by a centrifugal fan located within a plenum return room with filters. This fan is constant volume. Each space served has one or more terminal heating coils to provide independent temperature control. This fan and the terminal heating coils are original to the building.

- There is one (1) variable volume Air-Handling Unit (AHU) that serves the '93 addition area. This AHU utilizes HW heating and split DX cooling to condition the space. This unit serves multiple classrooms. Each classroom has an independent VAV terminal reheat box for temperature control.

- There is one (1) variable volume Air-Handling Unit (AHU) that serves the West '05 addition area. This AHU utilizes HW heating and split DX cooling to condition the space. This unit serves multiple classrooms. Each classroom has an independent VAV terminal reheat box for temperature control.

- There is one (1) variable volume Air-Handling Unit (AHU) that serves the East '05 addition area. This AHU utilizes HW heating and split DX cooling to condition the space. This unit serves multiple classrooms, the kitchen and multi-purpose room. Each space has one or more VAV terminal reheat boxes for temperature control.

- Implement a replacement plan that provides air conditioning throughout the original school.
- Primary:
 - Provide a chiller and primary pumping system to provide cooling.
 - Replace existing AHUs and unit ventilators serving classrooms with new vertical classroom unit ventilators with dual temperature coils to provide heating, cooling and ventilation to learning environments.
 - Size dual temperature water piping for future expansion capability to serve '05 addition.
 - Provide capability of plant to easily expand to accommodate expansion to serve '05 addition.
- Secondary:
 - Provide split DX cooling for new vertical unit ventilators and new AHU to serve original building interior spaces In lieu of chiller and dual temp distribution.

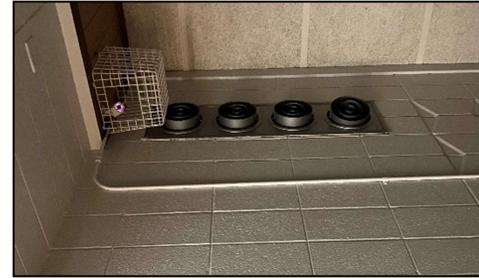
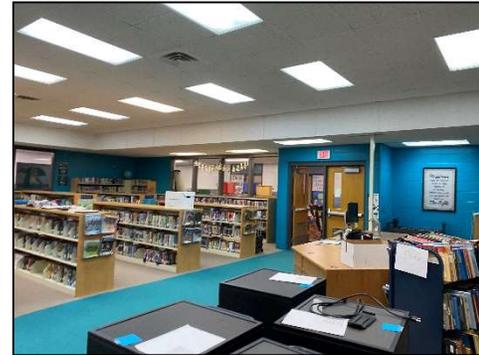
- The original school classrooms receive air directly from unit ventilators located within the occupied space.
- All other areas of the original school are served with overhead air distribution from the existing AHU. The AHU serves multiple spaces and utilize hot water terminal reheat coils serving one or more rooms. If a space temperature drops below the setpoint the HW coil valve will open and raise the supply air temperature to the space(s).

- The additions are served with overhead air distribution from the existing AHUs. The AHUs serves multiple spaces and utilize VAV terminal reheat boxes typically only serving a single room. If a space temperature rises above setpoint the VAV box will open to provide more cool air to the space. If a space temperature drops below the setpoint the VAV box reduces the amount of cool air supplied to the space. Upon further drop below setpoint the HW coil valve will open and raise the supply air temperature to the space(s).

- Provide new vertical classroom unit ventilators for original building classrooms.
- Replace terminal reheat coils with new coils capable of supporting full heating at 135F degree hot water supply temperature.

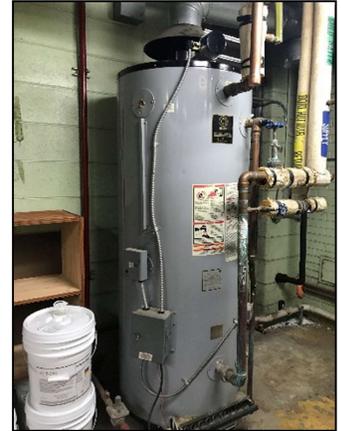
- The original school and '93 addition are served by a single standard efficiency gas fired hot water heater and recirculation pump. This unit has exceed its service life and should be replaced.
- The '05 addition is served by two (2) high efficiency gas fired hot water heaters and recirculation pump. These units are nearing their service life expectancy and should be budgeted to be replaced.

- Replace equipment at or exceeding the recommended service life. Replacement equipment should be high efficiency for operational energy savings.

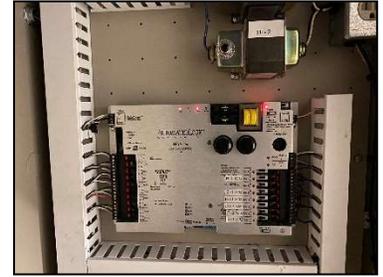
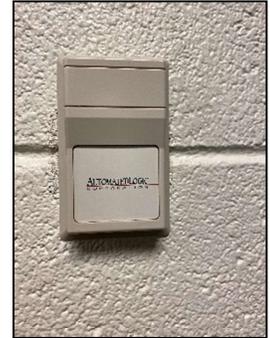
- Further evaluation of the control system is necessary to determine the expansion capability of the system.
- System is nearing the end of expected service life and may be due for replacement.

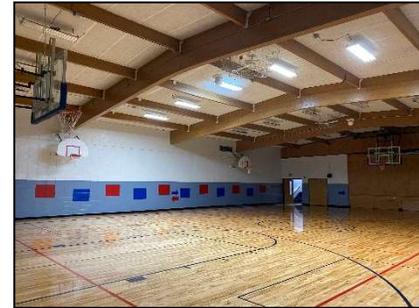
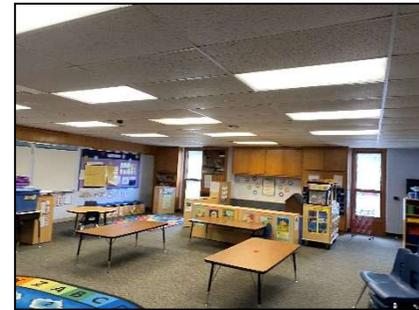
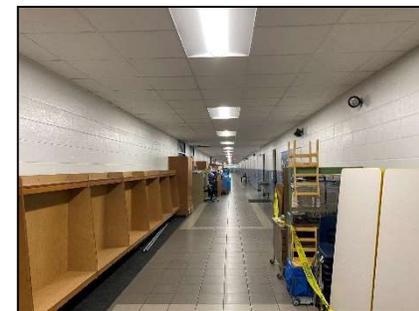
- All of the interior lighting appears to be existing fluorescent fixtures that illuminate the space learning environment, with the exception of the original building corridors that have been converted to LED fixtures. Converting the remaining fixtures to LED fixtures would allow for energy savings, tunable light (color and brightness) and minimize maintenance labor to replace bulbs. Most of the spaces were observed to have adequate light levels but there are areas, that have yellowing lenses or tubes, that would benefit from having consistent color temperature throughout the space. Additionally, sensitive environments where cooler light temperatures are needed can be addressed by installing fixtures that can adjust temperature with either a wall switch or phone-based application.

- The existing lighting controls are the original manual control wall switches with 1, 2, 3 or 4 scenes depending on the size of the space. These existing scene selectors help with zone control within each space to illuminate or cut lighting to the front learning area. Automatic controls in the form of occupancy or vacancy sensors should be considered to manage the lighting when spaces are not being used.

- Exterior lighting is minimal around the building represented by mostly wall sconces.

- Replace the existing fluorescent lighting with new LED fixtures with onboard wireless lighting controls (occupancy and daylighting). Replace the wall switches with new wireless programmable scene control switches.
